# Wastewater Management Options Assessment and Implementation Plan

Hyden Liquid Effluent Pond

Prepared for the Shire of Kondinin

Project Number: TW23048-V01

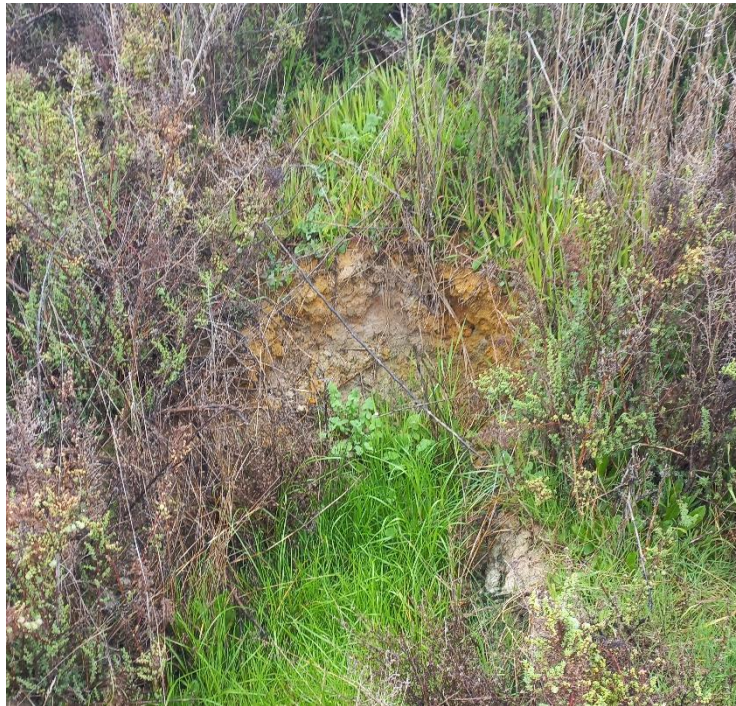
**Photo B-1: Vegetation and crumbling of pond outer bank**

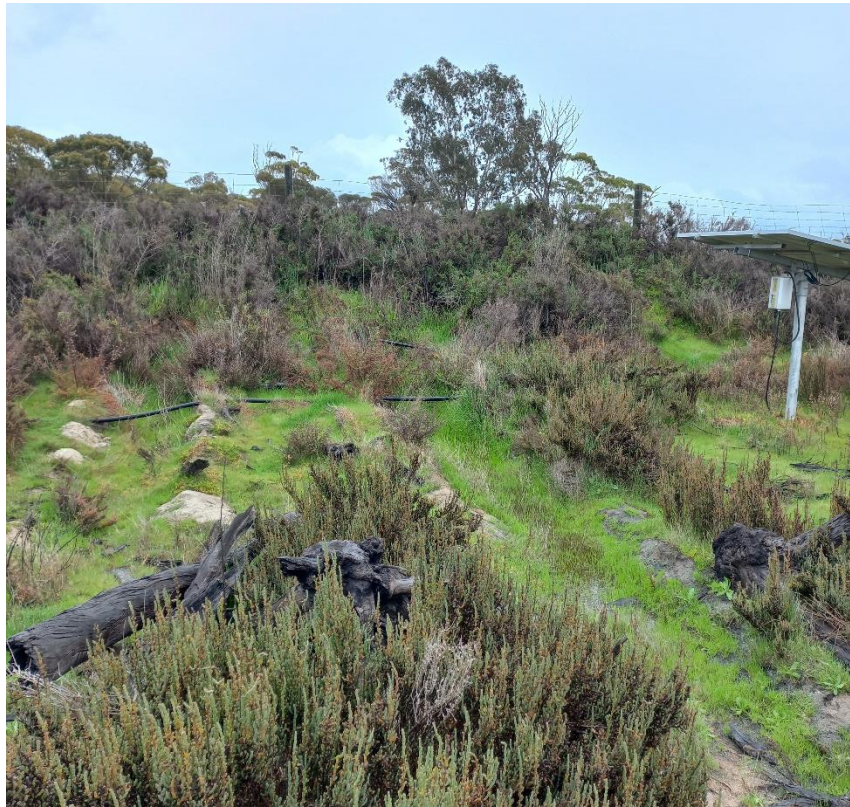
Overall, the pond was mostly non-compliant with the DoH Regulations, and significant remediation work would be required to bring the pond into compliance. Of particular concern is the stability and integrity of the pond. During inspections, Talis observed crumbling of the interior banks, potentially due to wind-driven waves. Extensive well-established vegetation, and a thinning of the bank in areas also contributed to the loss of integrity of the pond, with evidence of water and nutrient leakage particularly noticeable along the eastern extent of the pond.

**Photo B-2: Pond outer bank showing potential seepage and established vegetation**

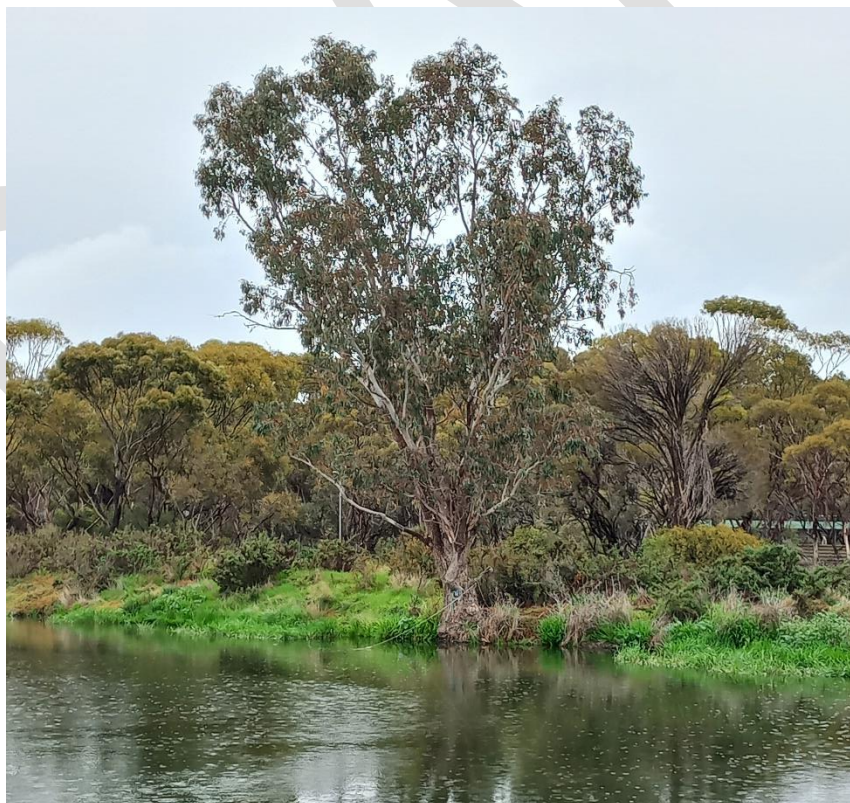
| Regulation | Description | Comments |
|---|---|---|
| 50(f)(v) | All overflow channels and drainage areas shall be kept free of weed growth; and | No determinable overflow from the pond was established, however vegetation was found on the external banks of the pond. |

**Photo B-3: Significant vegetation established in pond internal bank**

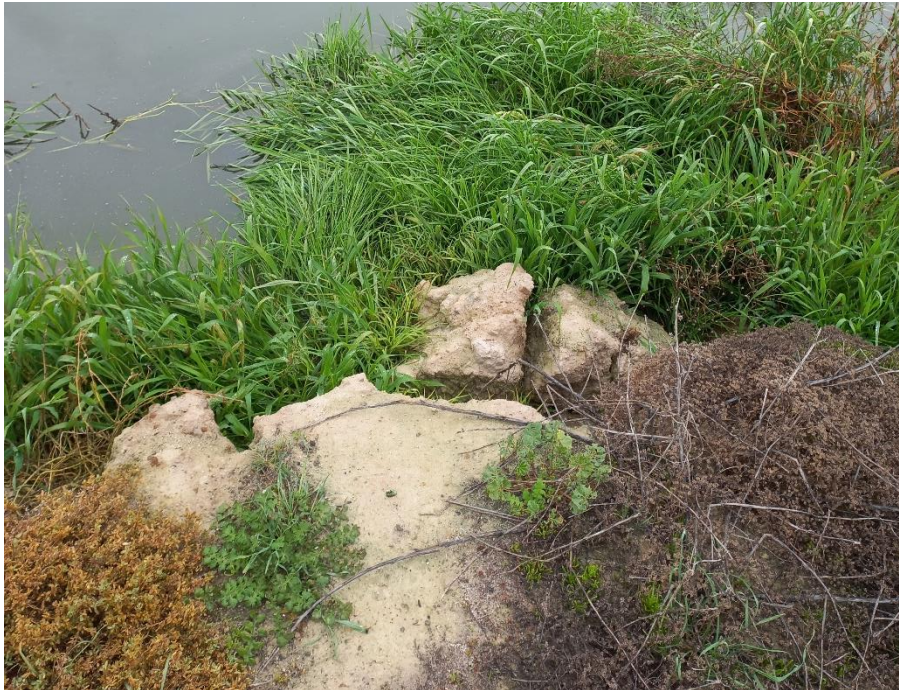
**Photo B-4: Evidence of internal pond banks crumbling**

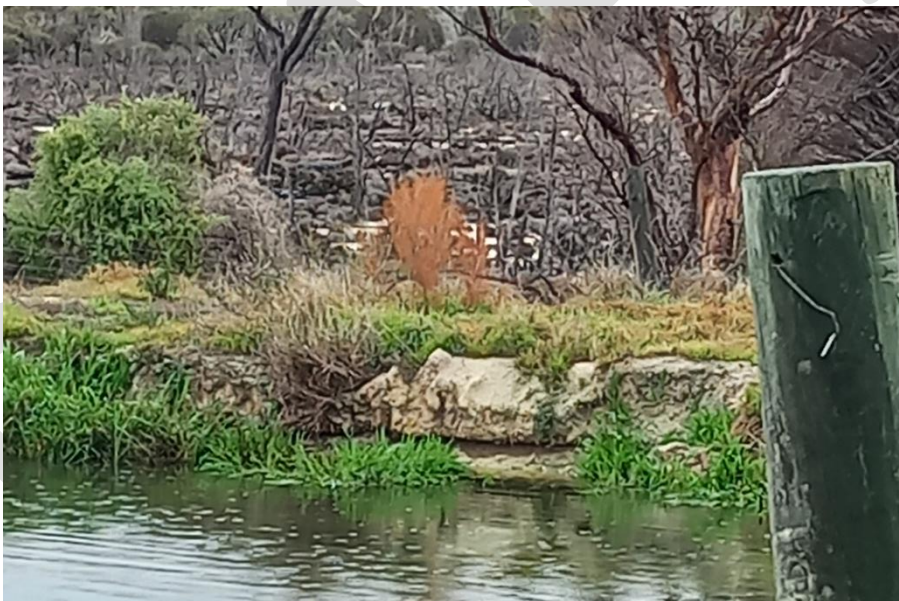
The WPQN #39 also recommends several design features, including a low permeability liner with a permeability less than  $10^{-9}$ m/s, and an emergency overflow weir to ensure the pond isn't damaged if it overtops. Embankment armouring is also recommended for protection against wave action in ponds with surface dimensions greater than 25m. Though the pond was observed to be constructed from a clayey material, the integrity of the liner is unlikely to be meeting this performance specification due to the presence of trees and shrubs growing in the pond, and the erosion of the internal pond banks. Damage to banks from may also be, in part, due to the lack of emergency overflow from the pond, as well as the lack of embankment protection.

**Photo B-5: Evidence of damage to internal pond banks from wind-driven wave action**

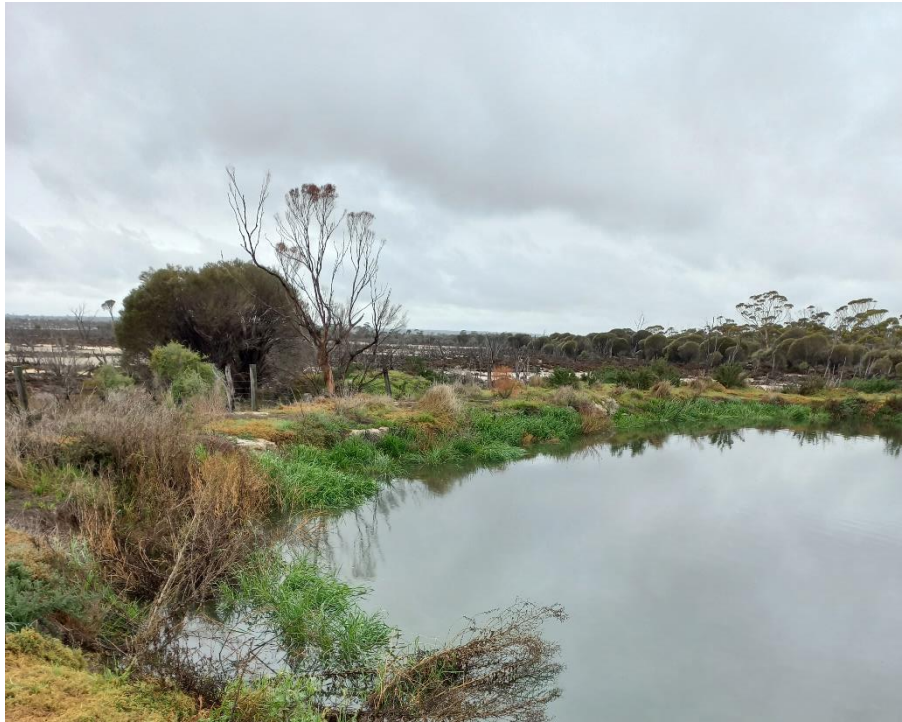
**Photo B-6: Incomplete pond fencing shown back right**
