Report on  
Geotechnical Investigation at  
36 Marshall Street, Hyden WA

For  
Hyden Progress Association

Reference: GI862725PG\_Rev0

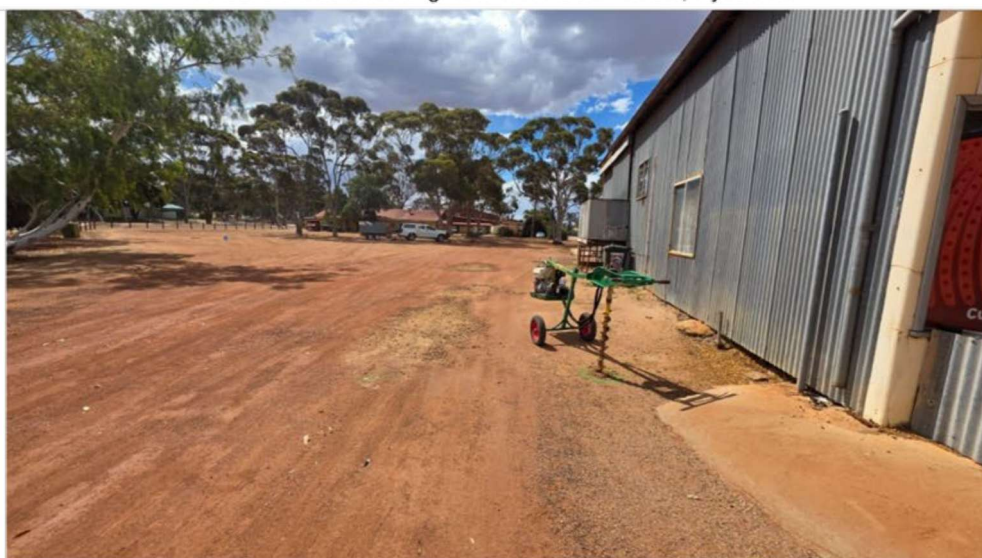
Photo 02: Subsurface probing by hand auger at Borehole BH6 location

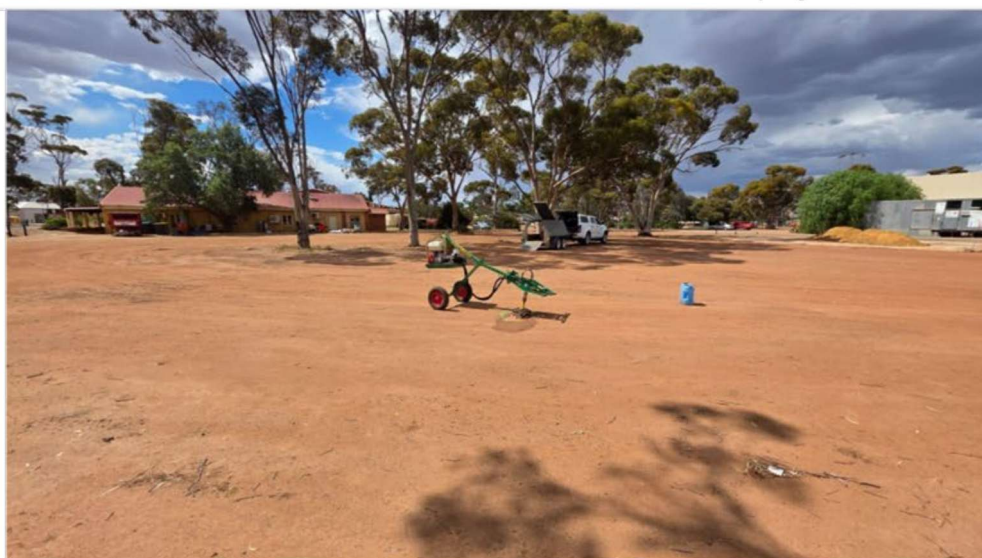
Photo 03: Subsurface probing by hand auger at Borehole BH2 location

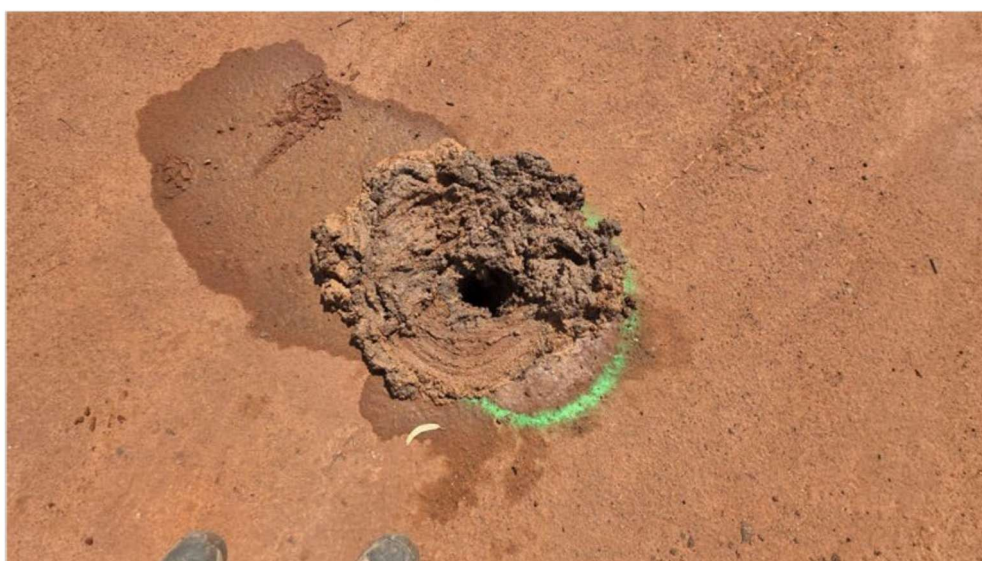
Photo 04: Soil from borehole location BH2

**0.2 – 1.7 m Gravelly Sandy CLAY**- medium plasticity, yellowish brown, pale grey, brown, dry to moist, stiff to hard, fine to medium grained sand, fine to coarse grained gravel.

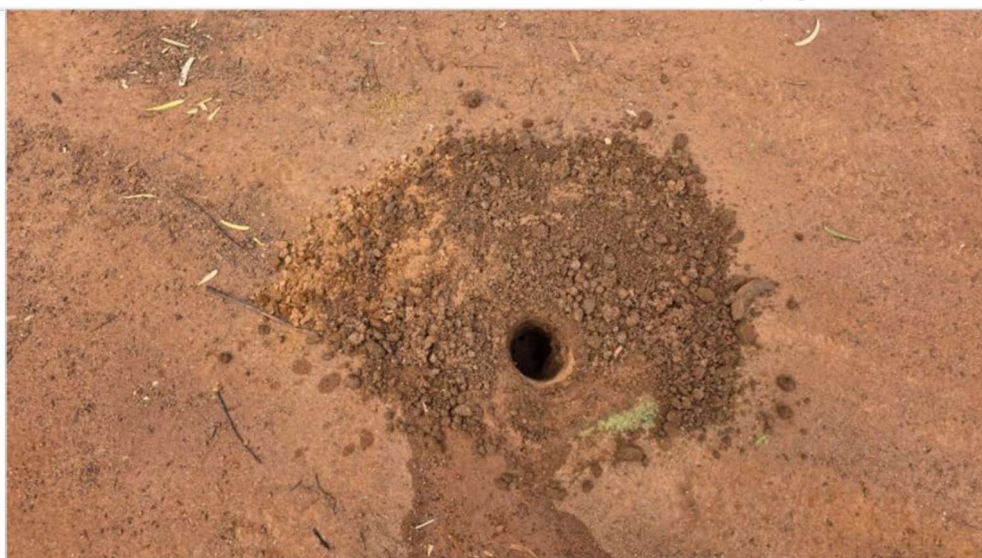
Photo 05: Soil from Borehole BH3 location

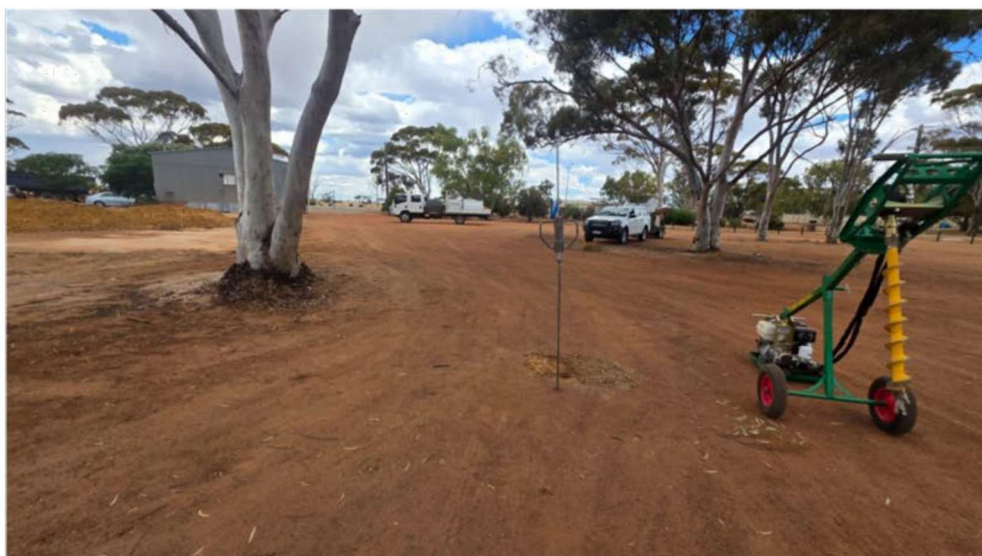
Photo 06: Conducting Dynamic Cone Penetrometer test at DCP1 location

Six (6) Dynamic Cone Penetrometer tests (DCP1 to DCP6) were conducted adjacent to borehole locations. All DCP tests were conducted to a depth of 2.0 m or refusal. The tests were conducted in accordance with test method AS1289.6.3.2, Ref Table 6.4.6.1 (A) & (B) HB 160-2006. DCP tests revealed that the site is in stiff to hard condition.

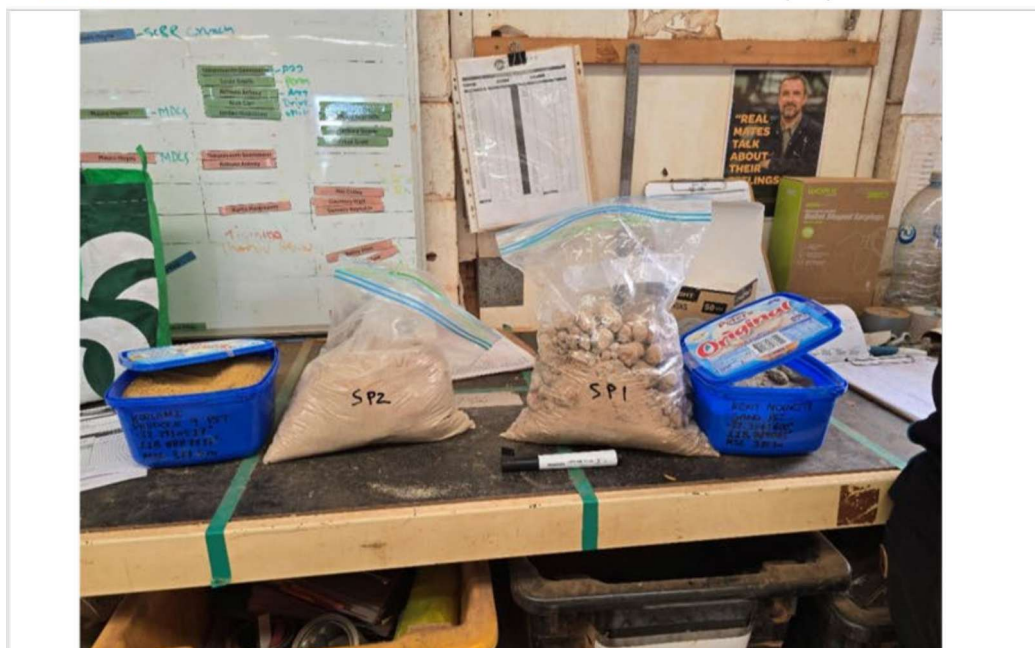
Photo 01: Soil samples for Laboratory tests

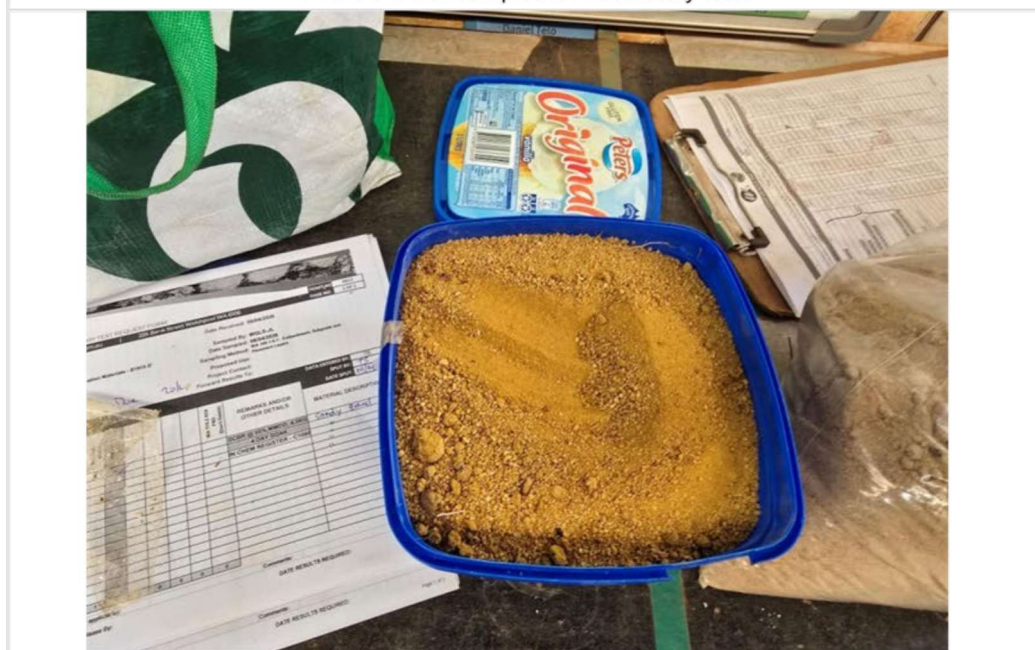
Photo 02: Soil Sample\_ Koolami Paddock 9 Pit

Koolami Paddock 9 pit, is not recommended for any engineering fill, can be used for garden bed, landscape area.

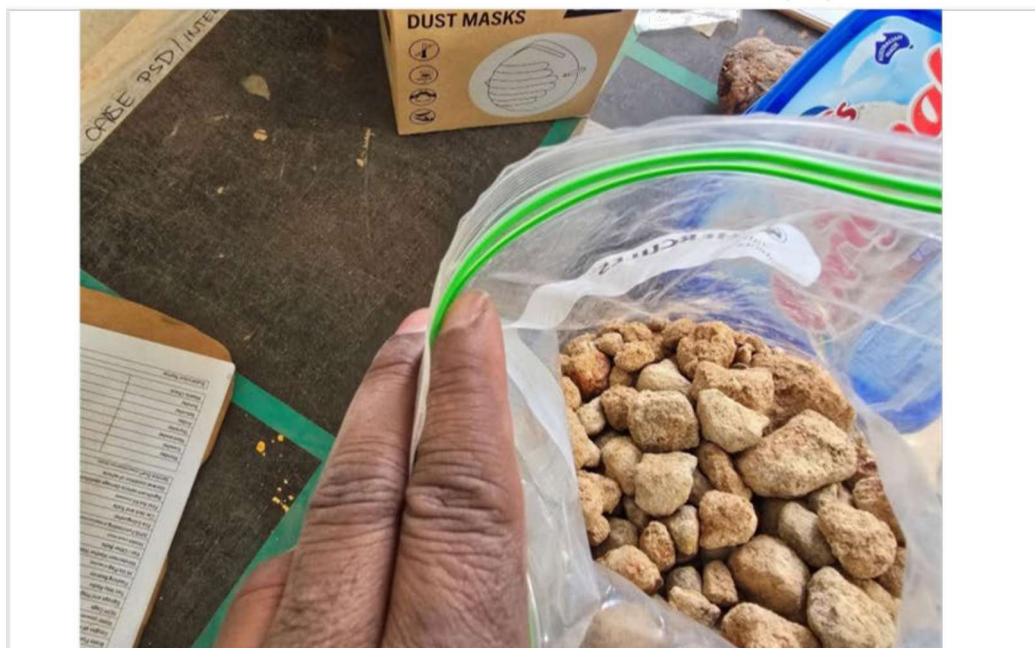
Photo 01: Stockpile sample\_ SP1

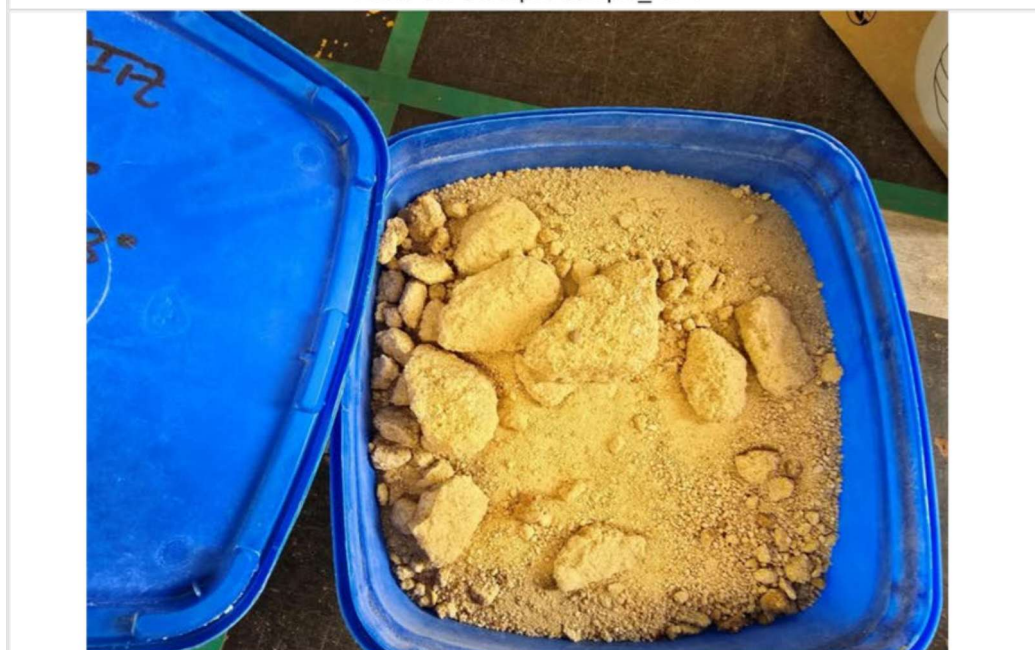
Photo 02: Soil Sample\_ Kent Mouritz Sand Pit
